EXECUTIVE SUMMARY

The Incident

An explosion occurred during a fireworks display held at a fete at the Holy Spirit Primary School, Sparkes Road, Bray Park at 19:47 hours on Saturday 20 May 2000. Three 2” Roman candles exploded and the steel tubes holding these Roman candles fragmented causing one fatality and resulting in seven people receiving serious injuries. Dominique Maree Baxendell, an 11-year-old grade 7 student at the Holy Spirit Primary School, received fatal injuries. People receiving serious injuries included the following:

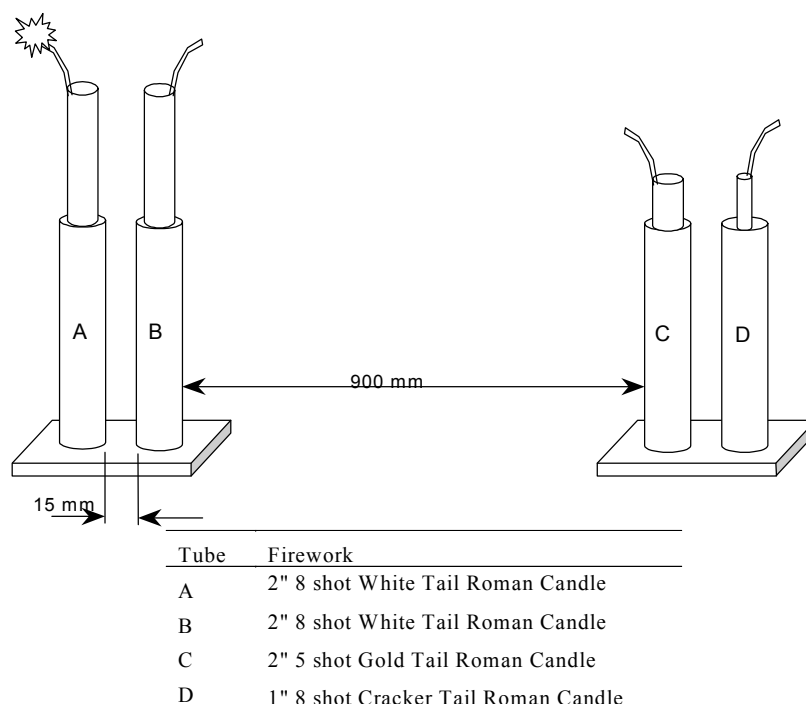
The Roman candles in twin tube steel fireworks stands involved in the explosion at the scene are shown below. The three 2” Roman candles in tubes A, B and C exploded. These Roman candles were the two 2” 8 shot white tail Roman candles in the twin tube steel fireworks stand (tubes A and B) and one 2” 5 shot gold tail Roman candle (tube C) in a twin tube steel fireworks stand 900mm away from the other Roman candles. Each firework stand consisted of a base plate with two steel tubes 500mm long, 76mm outside diameter and 3.6mm wall thickness welded to the base plate. The Roman candles were a close fit inside the steel tubes.

Figure ES 1: Configuration of Roman candle fireworks in twin tube steel fireworks stands

The energy released from the three exploding Roman candles fragmented the three steel tubes in which they were standing. Some of these steel fragments caused serious bodily injury and one fragment from tube B identified as Police Exhibit No: 119 struck Dominique Maree Baxendell. Fragments of various sizes were found at various distances up to approximately 175 meters from the blast centre. Fragments were found in the fireworks display area, spectator-viewing locations on the school oval, outside the barricaded-off safety zone area of the display, and the adjoining neighbourhood. Forty-two pieces of steel fragment were recovered.

The investigation has concluded that, in the operation of the 2" 8 shot white tail Roman candle in tube A, the first comet had functioned normally. A three second delay between the firing of the first and second comets being fired was expected. The second comet was expected to be expelled from the Roman candle when the explosion occurred. This Roman candle exploded due to the comet exploding. The comet exploded within a very short delay after ignition in close proximity to its at rest position in the Roman candle. The exploding comet caused the remaining unburnt comets and black powder in the Roman candle to explode en masse. The cause of the comet exploding was due to a physical feature in the comet, namely the porous and permeable nature of that comet. The porous and permeable nature of the comet allowed the burning rate of the comet, which is normally a controlled rate of burn like a cigarette type burn, to accelerate through the porous and permeable areas leading to an explosion.

Tube A expanded and impinged or struck the adjacent steel tube (tube B) approx. 15mm away containing a second Roman candle, causing the tube to be dented inwards. The dent compressed the contents of the second 2" 8 shot white tail Roman candle, causing that Roman candle to

A fragment or fragments from the first twin tube steel fireworks stand struck a second twin tube steel fireworks stand 900mm away containing the 2" 5 shot gold tail Roman candle in tube C. The point of fragment impact was approximately 200mm from the top of tube C. The 2" 5 shot gold tail Roman candle also exploded en masse. The explosion caused the tube to partially rupture producing several small fragments and one large fragment, with a steel collar being a part of this large fragment. Tube D was damaged but was not fragmented.

1. To prohibit the presence of any metal tube, holder, mortar, or other metal equipment that can confine a firework at any fireworks display site.
2. To prohibit unnecessary confinement of any firework.
